Impact survey to G deck anodized modular platform systems

TEST REPORT NUMBER TES000380TR-2

3G Metal Fabrications | Impact survey to G Deck modular platform system | November 14, 2017

Client: 3G metal fabrications

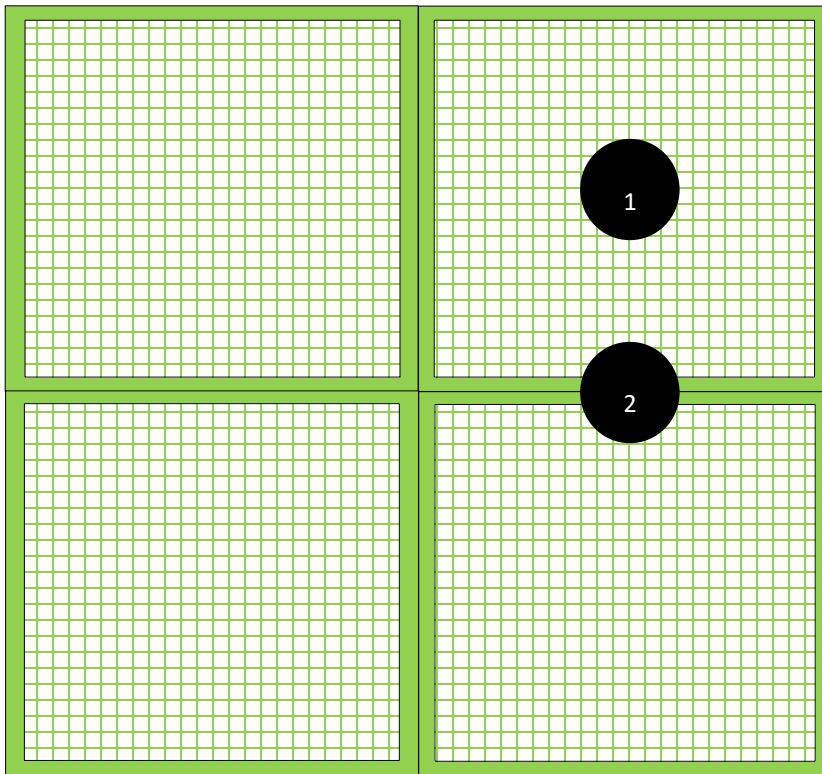
1.2. Impact zone schematic.

System assembled at 900mm platform height with bracing configuration all verticals braced, no securing pins inserted.

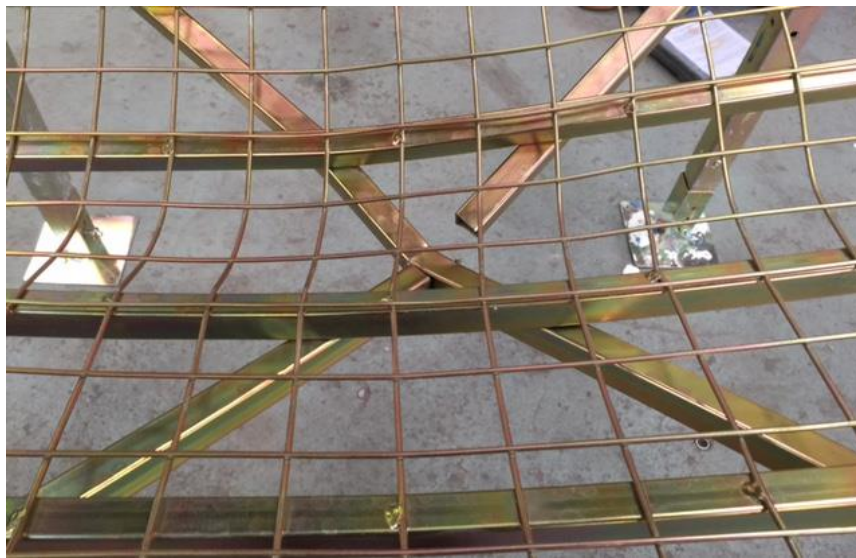
Test 1: Post 150kg impact at 3 meter drop height zone 1 test, central diagonal box section weld failure

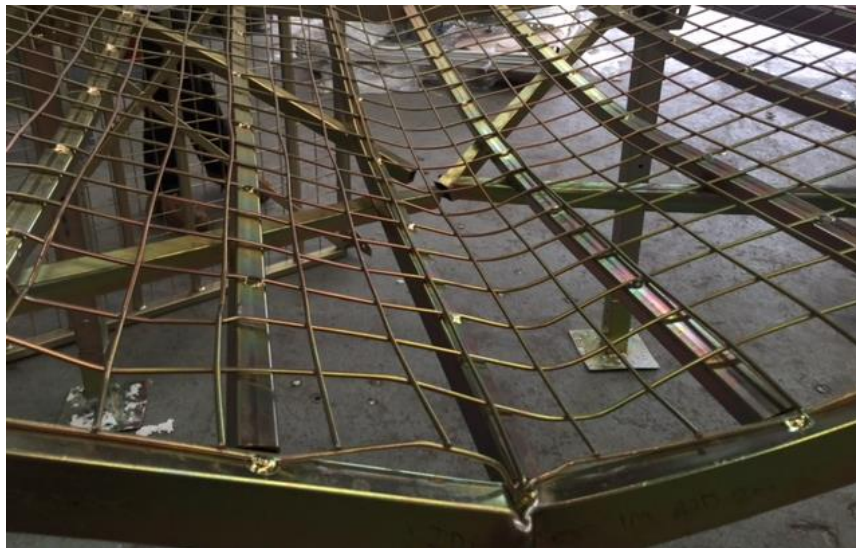
Test 2: Post 150kg impact at 3 meter drop height zone 1 test, central diagonal box section weld failure

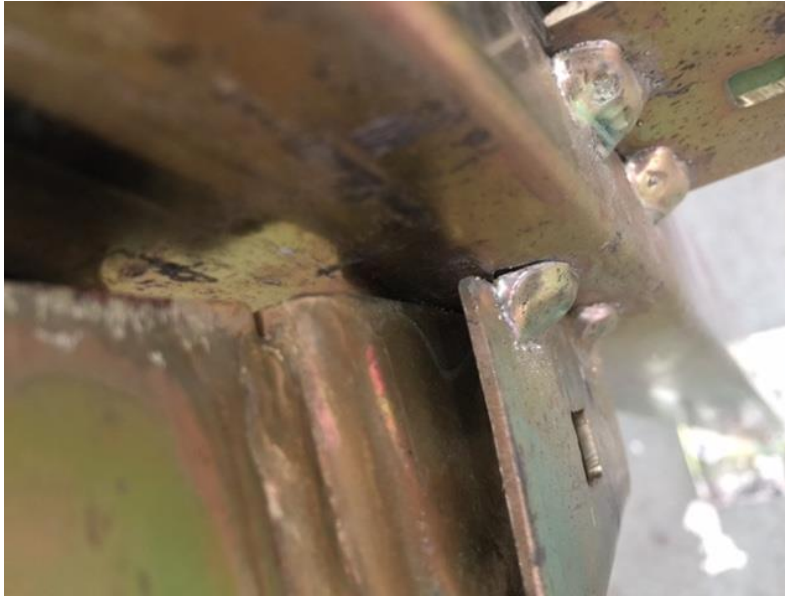
Test 1: post load zone 1 impact showing shark fin housing weld fracture

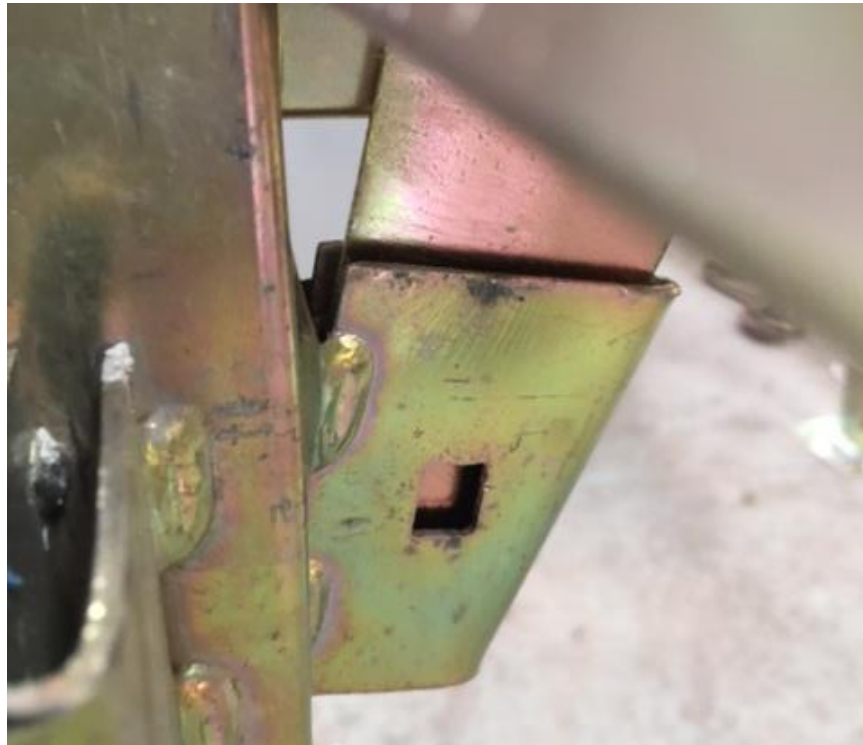
Typical of zone 1 impact, shark fin housing material tear

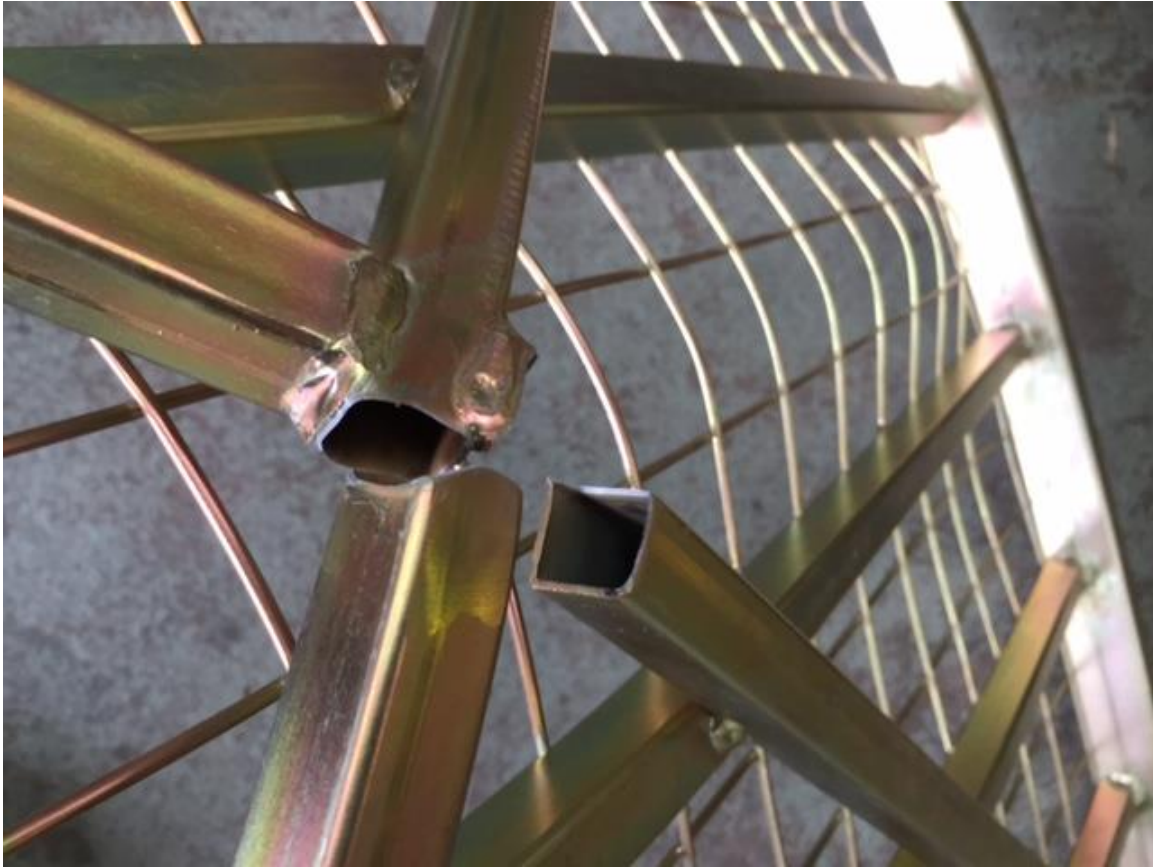
Zone 1 impact test 2 showing parent material/weld fracture

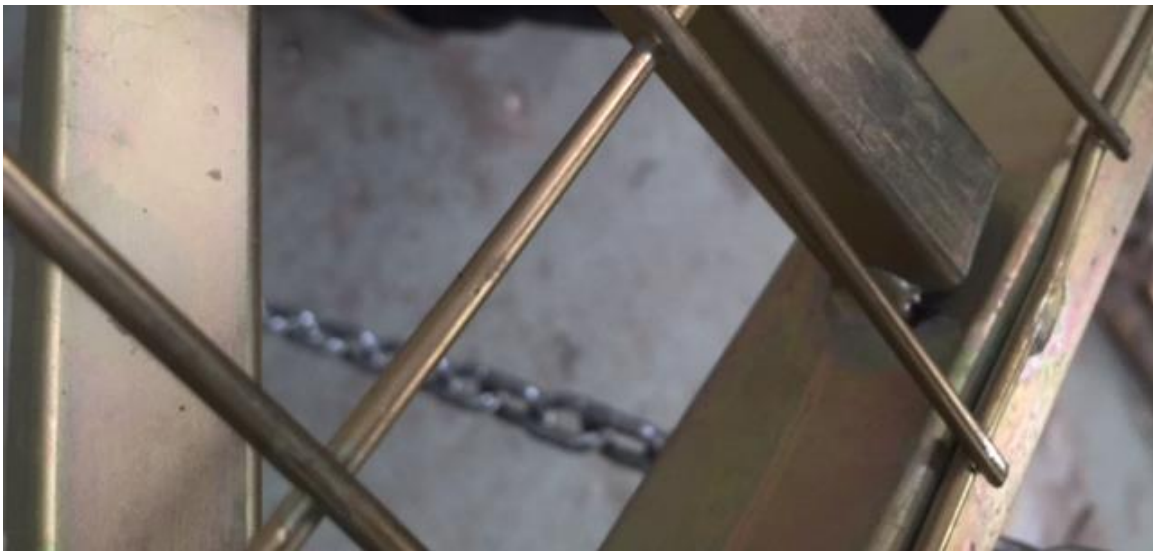
Image showing lateral box section weld fracture following zone 1 impact typical both tests

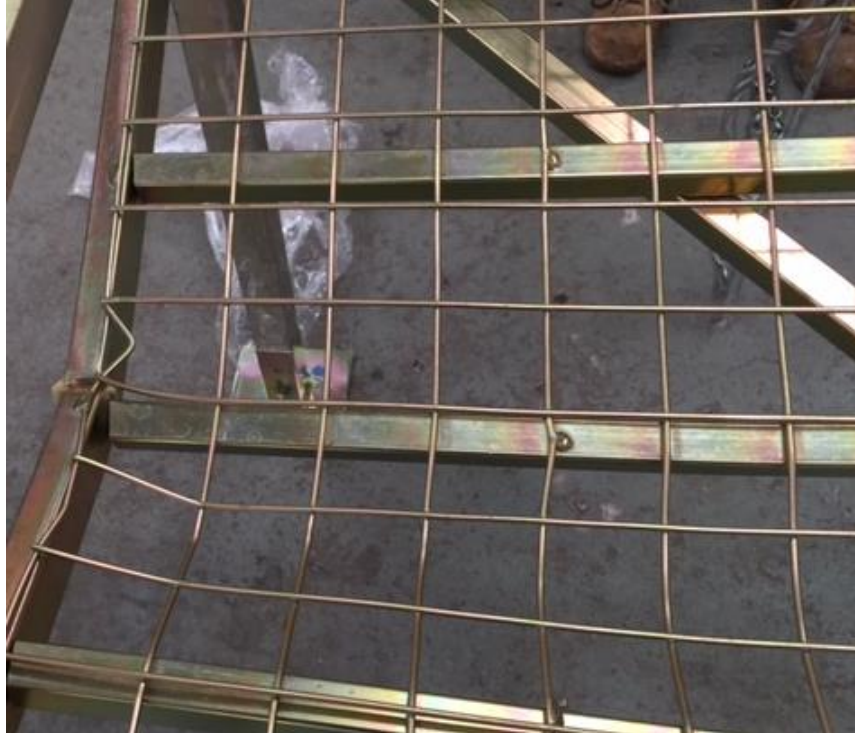
Outer perimeter box section deformation following impact zone 2

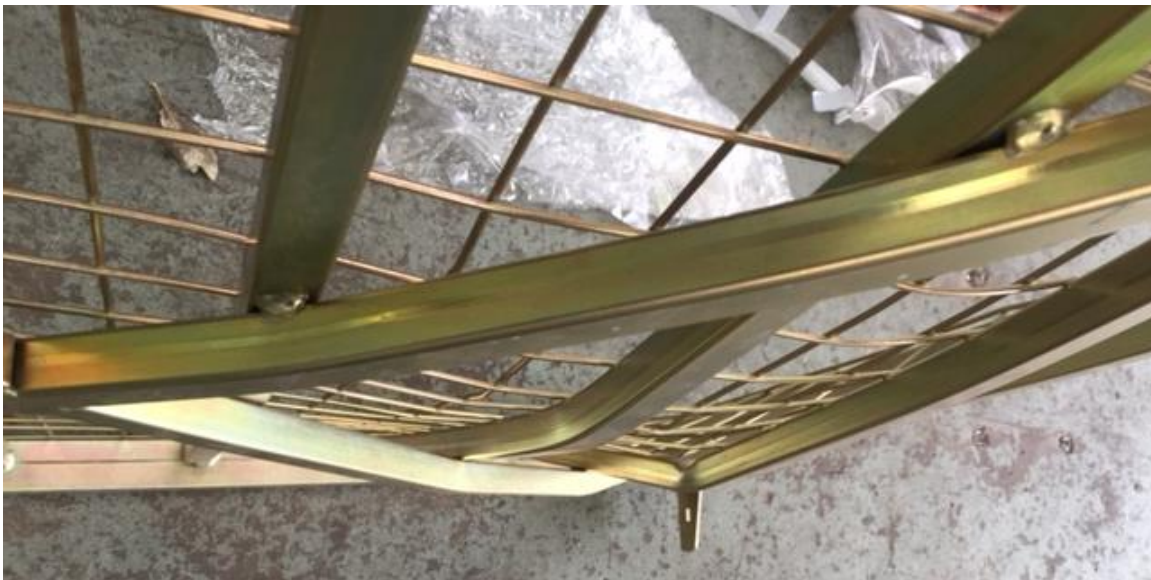
Post impact image showing brace deformation, zone 2

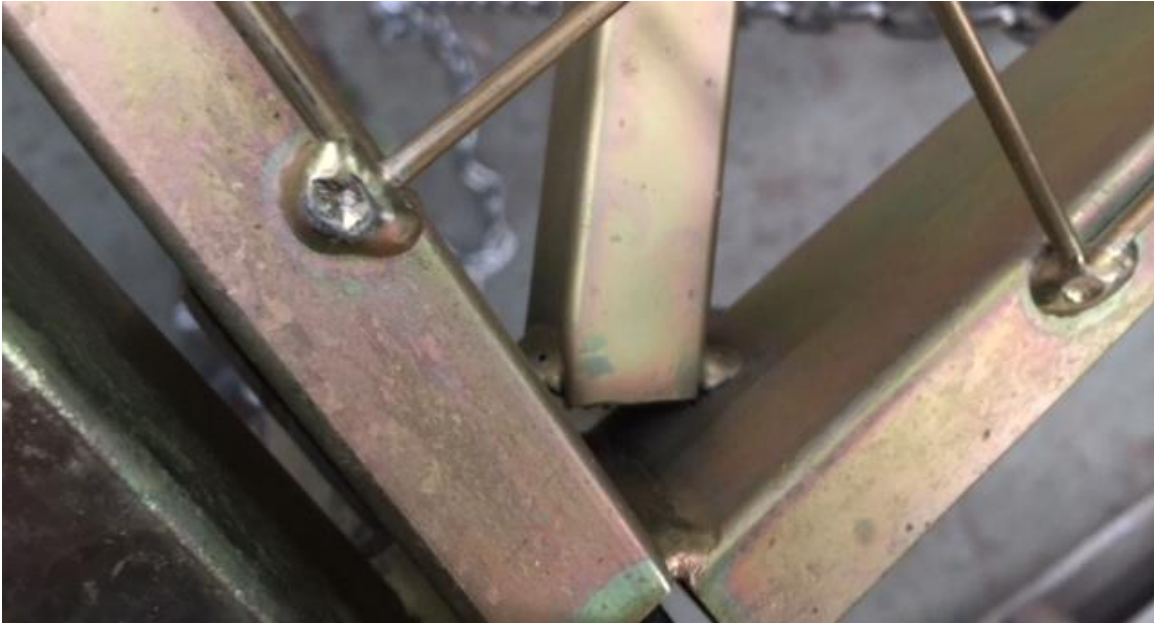
image showing diagonal brace weld fracture following zone 2 impact

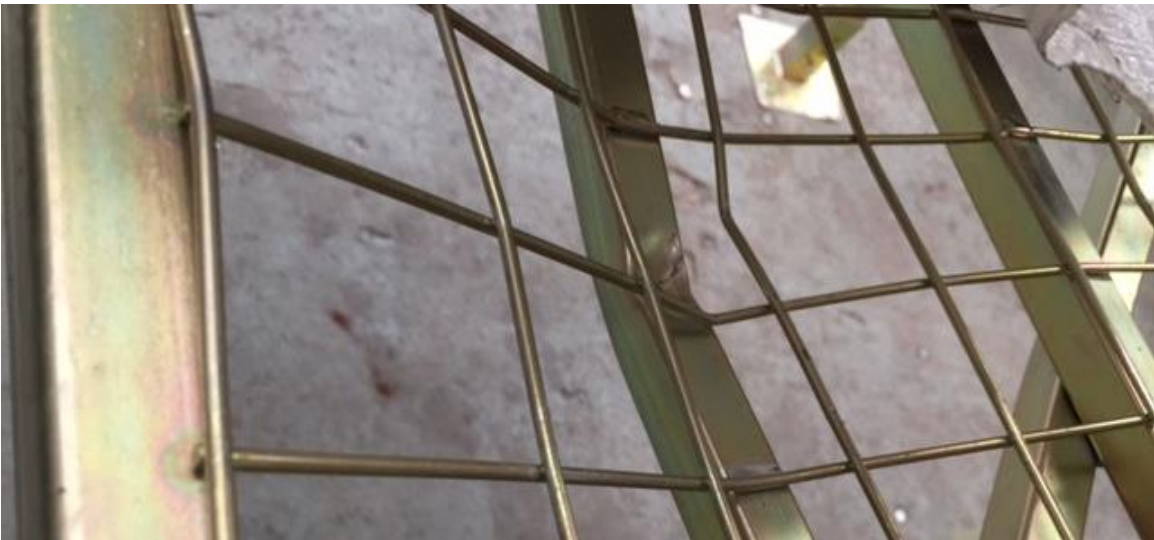
Image showing localized post impact deformation to lateral box section brace

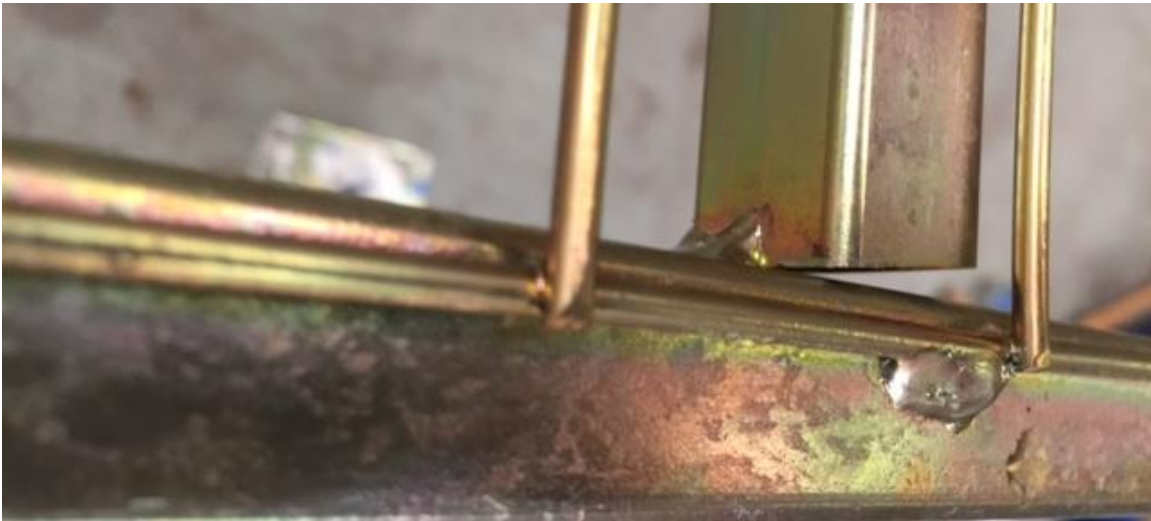
Lateral box section deformation shown following zone 2 impact

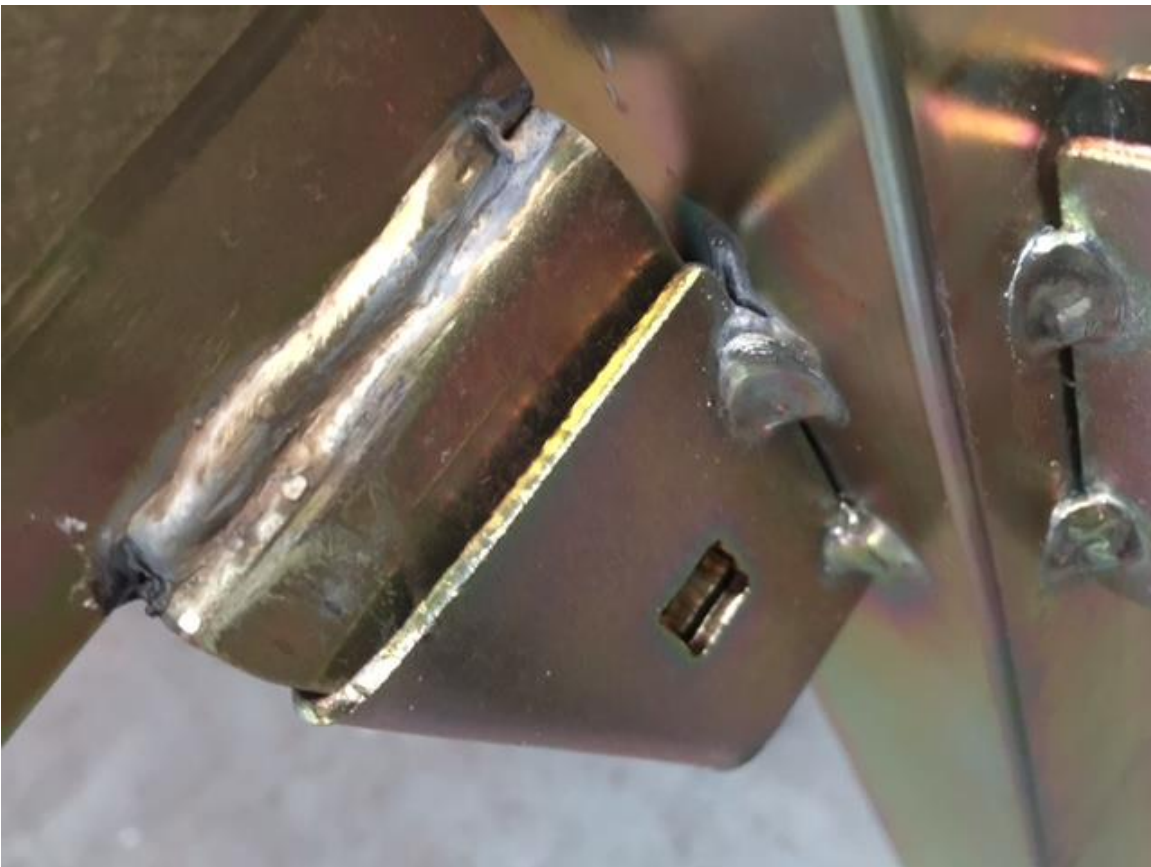
Weld fracture to shark fin housing following zone 2 impact.

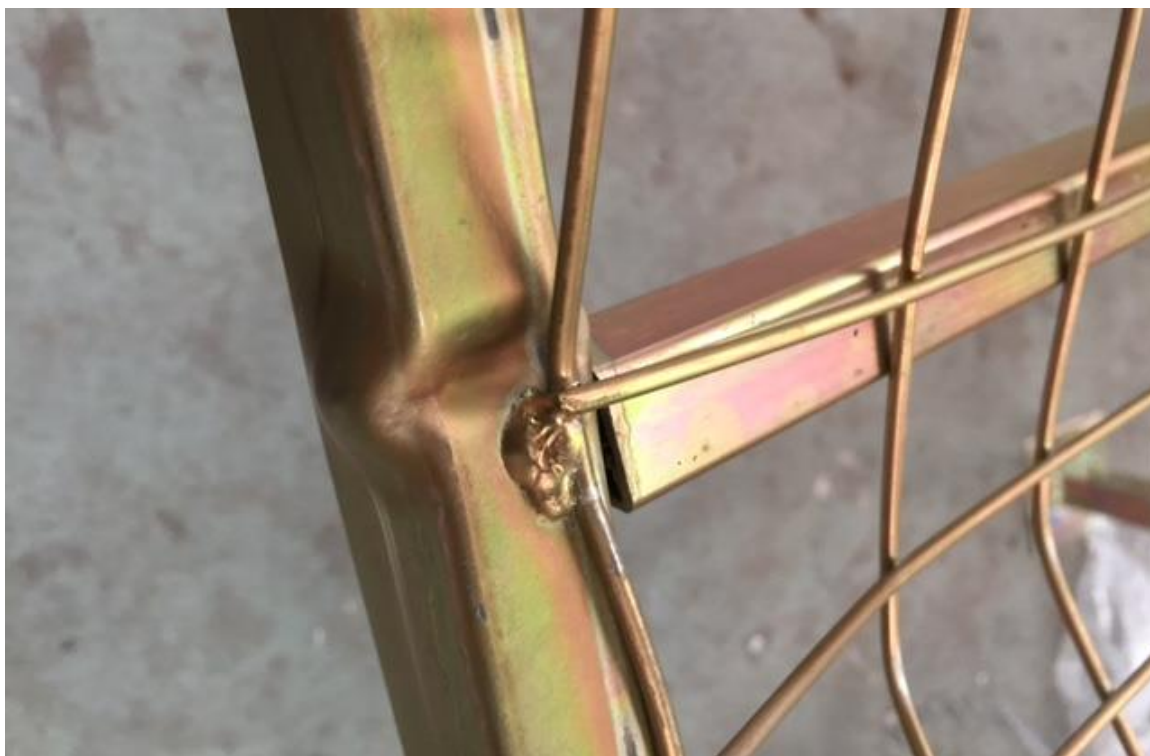
Compressive buckling of outer frame following impact zone 2
